PERMEABLE GRASS PAVERS Greening the Department of Public Works (DPW) Facility in the Troy Brook Watershed

Implementation Project completed by Rutgers Cooperative Extension Water Resources Program and Rutgers Cooperative Extension of Morris County under a 319(h) Grant from the NJ Department of Environmental Protection,

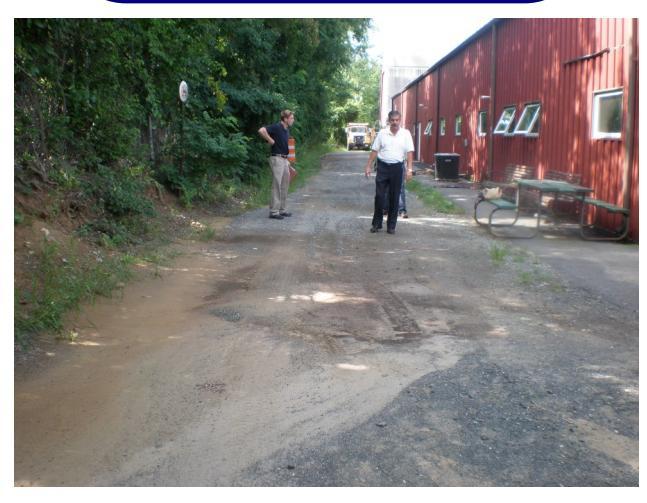
The emergency access road behind the DPW facility building was a dirt road that sloped towards the Troy Brook.

The Troy Brook is adjacent to the Parsippany-Troy Hills Department of Public Works (DPW) facility. The Troy Brook has an impairment for biological life, and the Troy Brook Regional Stormwater Management Plan has identified the DPW facility as an area that contributes to localized flooding issues in the stream. The emergency access road behind the buildings had previously allowed stormwater runoff to the stream.

The stormwater runoff carried sediment and phosphorus, while the runoff from the roof downspouts ponded and caused flooding in the offices in the building.

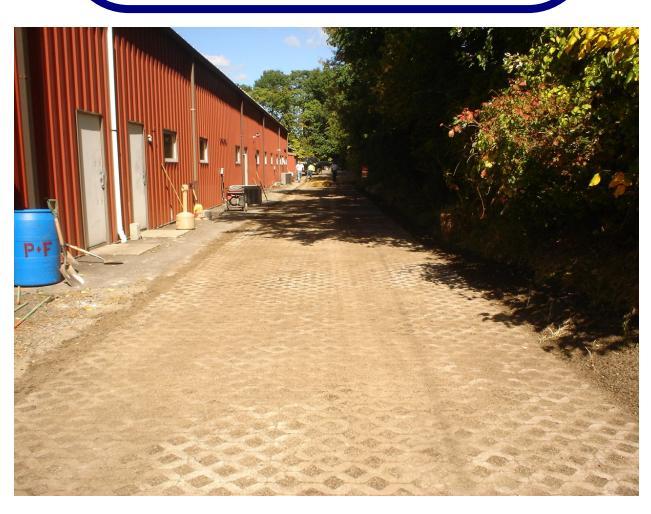
Long view of the pavers immediately after installation. Photo credit Pat Rector, 9/25/2009

Utilizing funding from a Section 319(h) of the Clean Water Act grant from the NJDEP, permeable grass pavers were installed. Grass pavers are placed on roads or parking areas that do not receive heavy traffic. The pavers allow grass to grow between them, facilitating infiltration and decreasing the amount of runoff from the area. The pavers have reduced stormwater runoff from the road area and the side bank. Drainage from the rooftop that had previously caused flooding in the offices is also directed to the pavers, and the rooftop runoff is infiltrated. The offices no longer flood. During Hurricane Irene when Parsippany-Troy Hills received over seven inches of rain, the office in the building did not have any water whatsoever!

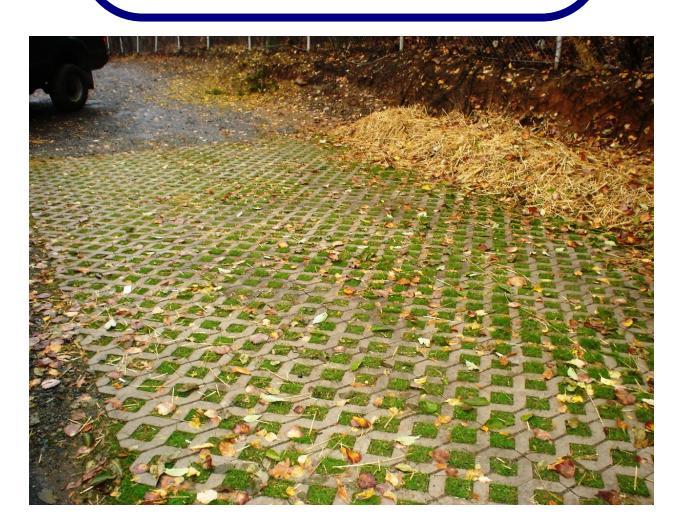
Grass Pavers at Parsippany-Troy Hills Department of Public Works Facility Emergency Access Road during a rain storm — note there is no runoff from the grass paver areas. Photo credit Pat Rector

The grass paver area is approximately 180 ft. x 12 ft. (2,160ft²), with runoff of approx. 2,000 ft² from the road and 7,160 ft² from the roof. An estimated 105,862 gallons/yr. of rainwater is now being captured and treated onsite.

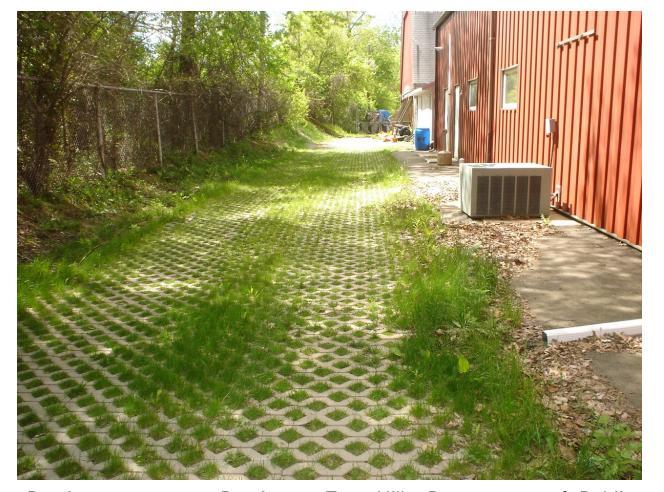
Pervious pavers at Parsippany-Troy Hills Department of Public Works facility Emergency Access Road. Note the downspout from the roof leading to the pavers. Photo credit Pat Rector, 5/2011
